TECHNICAL SERVICE BULLETIN**No.19-2378**
12 December 2019

Subject/Concern:	Buzz noise from the engine compartment audible in the interior mainly from the front left foot area during driving, when the engine is hot (> 90°C) and engine speed between 1600-2000 rpm especially at warm ambient conditions
Model:	
Fiesta 2017.0 (01/2017-)	Build Date: 01.05.2017 – 11.11.2019 Build Code: HB – KM Assembly Plant: Niehl (Cologne) Engine: 1.0L EcoBoost (74kW/100PS) Engine: 1.0L EcoBoost (90kW/120PS) Engine: 1.5L EcoBoost (147kW/200PS) - I3 (YZ)
Fiesta 2017.0 (01/2017-)	Build Date: 01.05.2017 Onwards Build Code: HB Onwards Assembly Plant: Niehl (Cologne) Engine: 1.0L EcoBoost (70kW/95PS) Transmission/Transaxle: - 6-Speed Automatic Transmission – 6F15
Fiesta 2017.0 (01/2017-)	Build Date: 01.05.2017 Onwards Build Code: HB Onwards Assembly Plant: Niehl (Cologne) Engine: 1.0L EcoBoost (103kW/140PS) (YY)

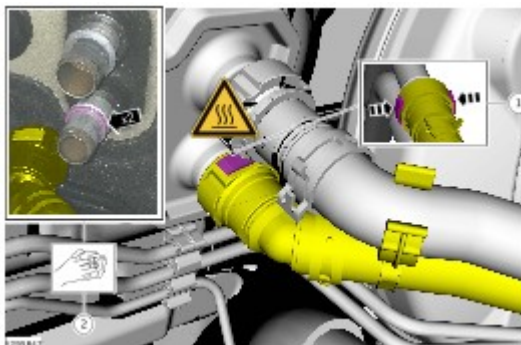
Should a customer express concern about buzz noise from the engine compartment audible in the interior mainly from the front left foot area during driving, when the engine is hot (> 90°C) and engine speed between 1600-2000 rpm especially at warm ambient conditions, the probable cause is excessive clearance between the heater hose quick connector to the heater core spigot.

Install two O-ring seals on the **lower** spigot.

1. Disconnect the **lower** quick connector from the heater core spigot.
2. Clean the spigot from coolant residues and install the O-ring seals (see Parts Required).
3. Install the lower quick connector and ensure an rectangular installation position. Push slightly until you notice an audible click from the quick connector. Don't push the quick connector too far otherwise the O-ring seals will be pushed above the bead on the spigot.
