Water Leaks

General

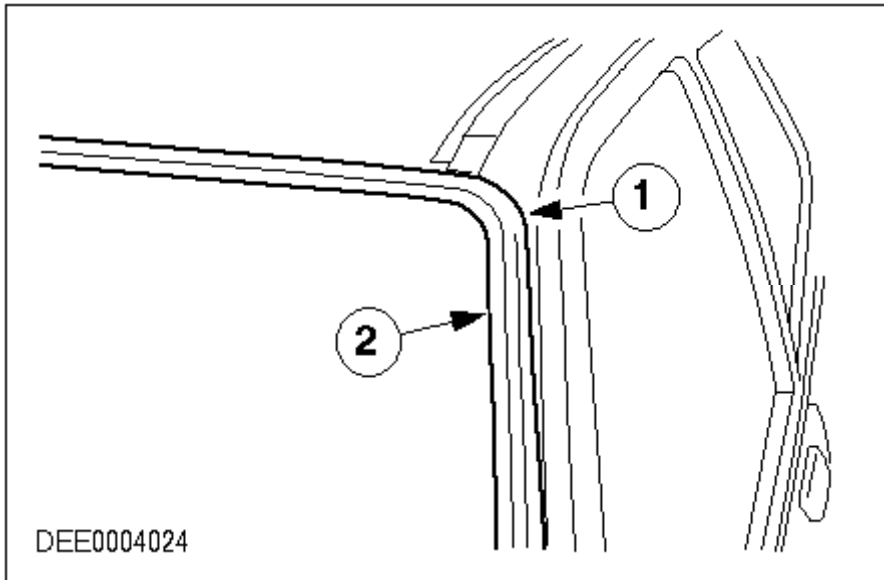
Windscreen seal

- Diagnosis:
 - Ingress of water into A-pillar area
- Cause:
 - An old or incorrectly fitted seal can cause insufficient or irregular clamping load of the rubber

seal on the windscreen or window frame. This results in water ingress between the rubber seal and the windscreen or between the rubber seal and the window frame.

- Corrective action:
 - Seal the problem area using window sealing compound between the rubber seal and the windscreen, or between the seal and the window frame. Wipe off excess sealing compound immediately.
 - If a new leak is found after the necessary leak check, then the rubber seal must be renewed.

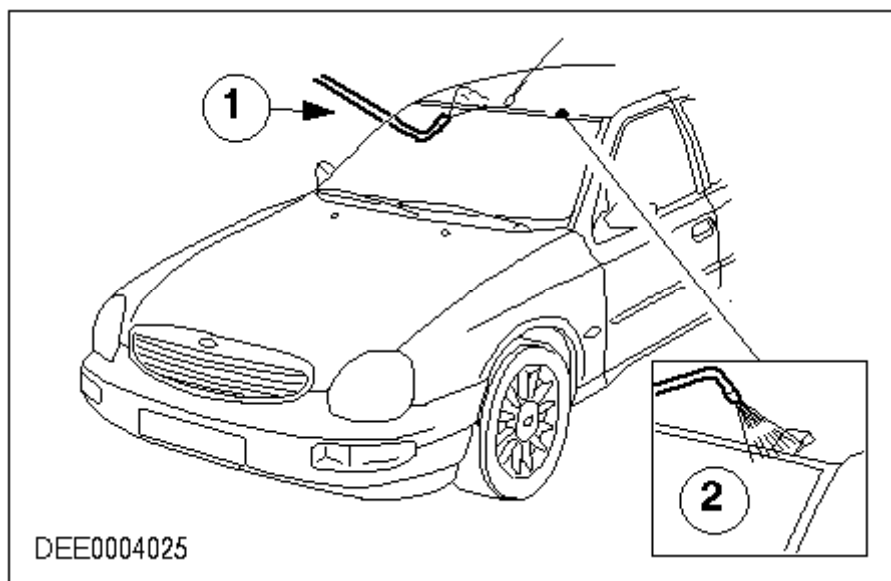
Diagnosis of a water leak

- Diagnosis:
 - Ingress of water into A-pillar area or instrument cluster area
- Cause:
 - Breaks in adhesive beads
- Corrective action:
 - **Note:**
The repair must be carried out in line with approved methods (service microfiche/TIS CD group 42/501-11).

The breaks in adhesive beads can be located from inside by using compressed air. The leak can be identified from outside by the escaping air.
 - The second test method is by means of a water test. The outer cover must also be raised carefully using a plastic wedge. The leak should be located from inside by a second assistant.

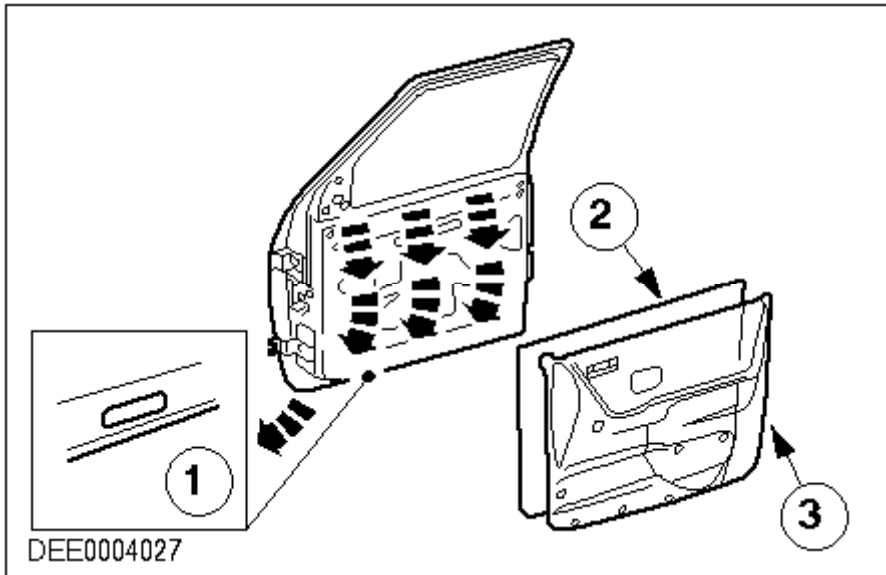
Door seal

- Water ingress in the lower part of the interior door trim or in the rocker panel area.
- Cause:
 - The water shield or foam watershield fitted behind the interior door trim exists to drain off water that has entered the door via the drainage holes, either downwards or outwards. If the water shield or foam watershield is damaged or has been fitted incorrectly, then water can get into the passenger compartment.
 - In addition to this, the drainage holes can become clogged with leaves, dirt or excess cavity protection agents. Water gathers in the door and ingresses into the passenger compartment.
 - **Note:**
If a water shield or foam watershield becomes damaged in any way, then it must always be renewed.

Check water shield or foam watershield for damage or correct fitting.

- Before the water shield or foam watershield is installed, the drainage holes must be checked for unhindered flow.- Corrective action:
 - **Note:**
When installing the butyl tape, do not touch the mating surface (this impairs the adhesion).

Detach the interior door trim.

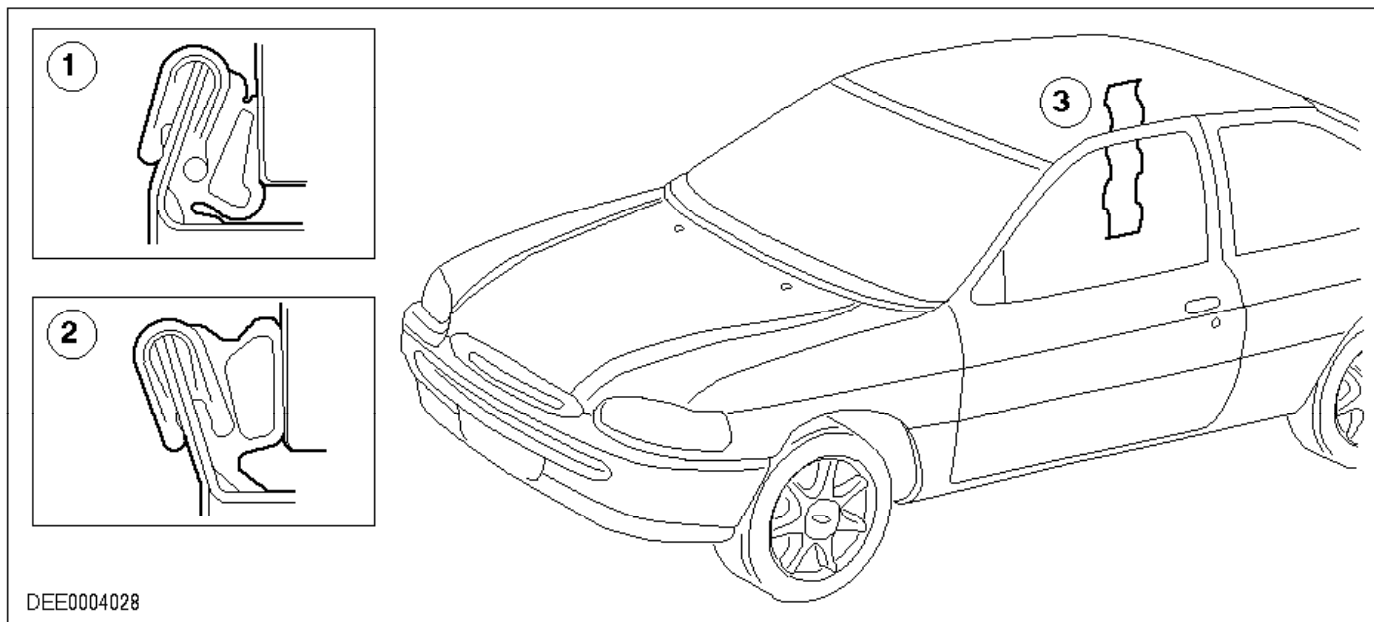
Checking the seal

- Diagnosis:
 - Ingress of water into the rocker panel area
- Cause:
 - Insufficient clamping load between seal and door.
- Corrective action:
 - Check clamping load:
 - The easiest way to check the clamping load of a seal to the respective bearing surface is by means of a paper strip test. This consists of trapping strips of paper at various points between the door and the seal, and fully closing the door. If it is possible to pull out the paper with no great resistance, then the clamping load is too low.
 - Adjust the clamping load:
 - **Note:**
When adjusting the clamping load, the edge alignment of the relevant components must always be taken into consideration.

Item	Part Number	Description
1	-	Panel flange bent too far inwards: small bearing surface
2	-	Panel flange adjusted correctly: correct bearing surface
3	-	Check clamping load with a strip of paper

The clamping load is normally adjusted using the striker. When doing so, the edge alignment from the door to the side panel, or from the front door to the rear door must be taken into account.
 - Another setting method is to realign the panel flange for the seal mounting. The clamping load is increased by moving the flange towards the door.
 - **Note:**
Do not realign the flange too far in the direction of the door, as this can reduce the bearing surface of the seal to the door.

Check the bearing surface:
 - Apply chalk evenly to the surface of the seal. Evenly coat the bearing surface of the door with vaseline.
 - Close the door fully, the lock must engage. Open the door. The imprint of the chalk (bearing surface) can be identified in the film of grease.
 - The bearing surface should be at least 5mm across at all points.

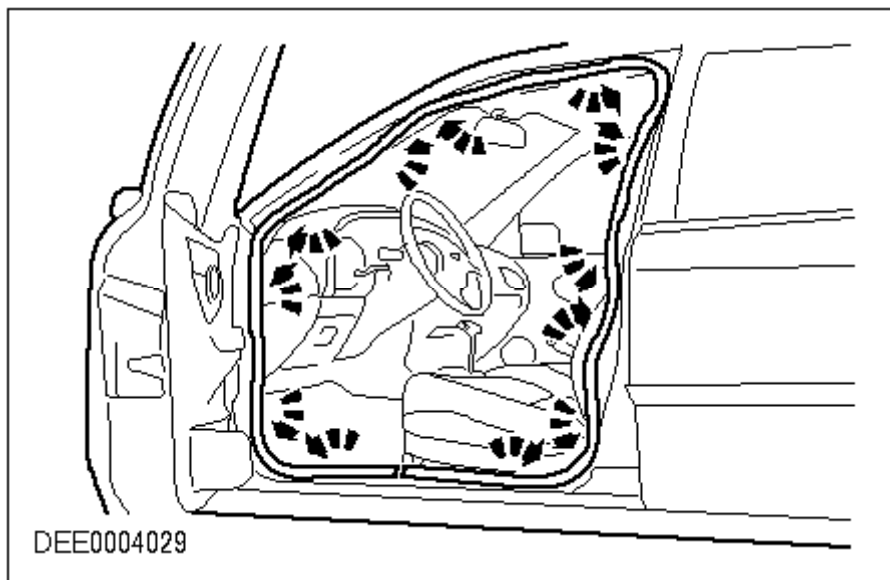
Correct installation of the door seal

- The door seal must completely seal the door where it meets the bodywork.
- Water can ingress directly or indirectly into the interior of the vehicle if the seal is damaged at any point.

- A damaged or worn door seal must always be renewed in full.
- When renewing the seal, the following must be taken into account:
 - Always fit the seal first in the area of the narrow radii (corner points).
 - Next, secure the seal to the flange evenly by tapping lightly with a rubber hammer. The installed seal must not be kinked at any point.

The prescribed length of a seal must not be shortened.

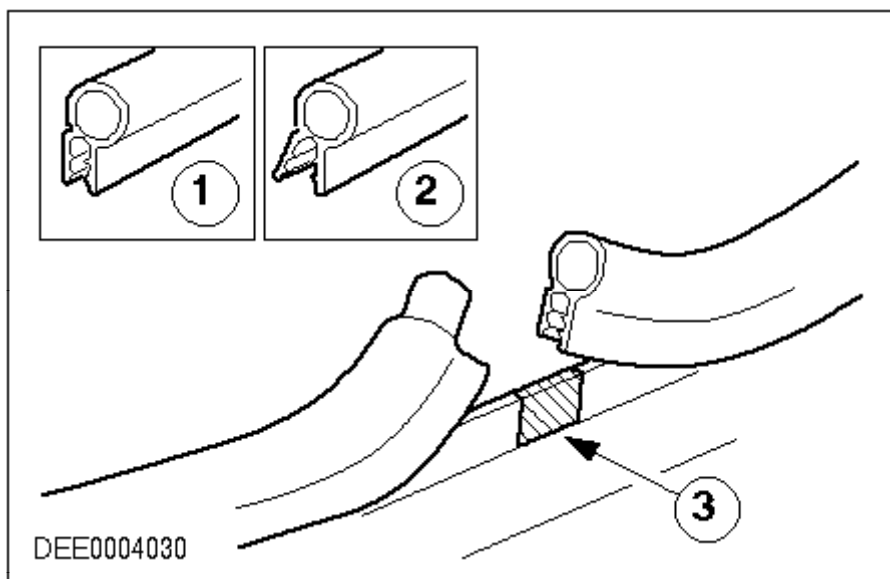
Door seal leaks

- The door seal is attached to the welded flange all the way round. If this welded flange is uneven or damaged at any point (usually in areas with narrow radii) then this point could be subject to leaks.
- A stretched seal carrier can also cause a leak.
- In both cases, water gets into the vehicle interior under the seal carrier.

Item	Part Number	Description
1	-	Correct seal carrier
2	-	Stretched seal carrier
3	-	Seal on connecting joint

- Align the deformed welded flange using a hammer and anvil block, prevent and if necessary repair any paint damage.

A stretched seal carrier must be realigned by hand. If this is no longer possible, the seal must be renewed.

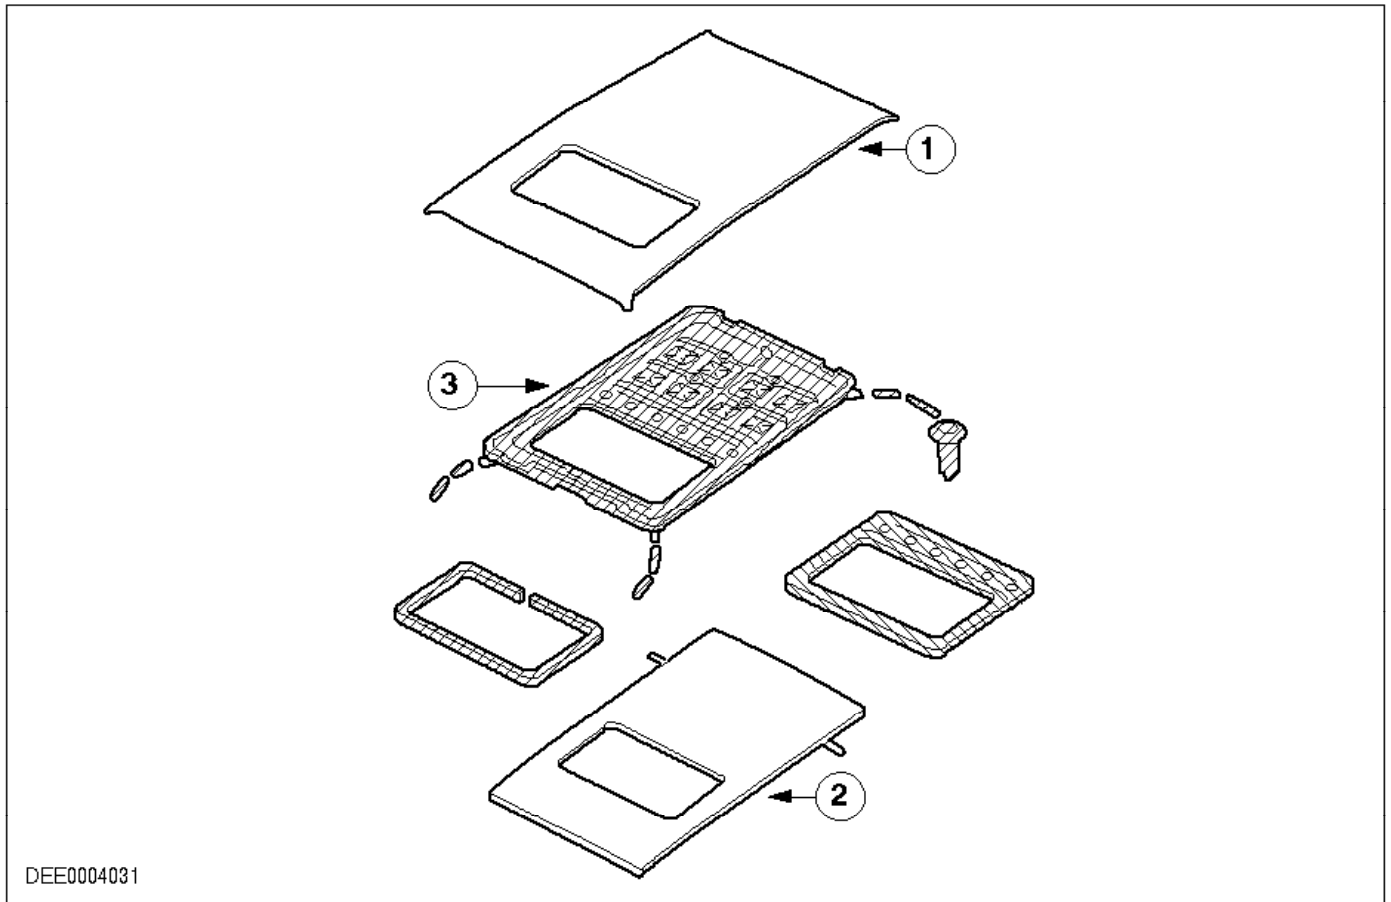
Sliding roof/tilting roof

- Diagnosis:
 - Ingress of water at sliding roof aperture
- Cause:
 - The sliding roof/tilting roof is installed in a water trap. The water drains off via the water trap, water drain holes and drain hoses. The drain hoses lead downwards on both sides via the A-pillar and C-pillar.
 - The drain holes or drain hoses can become clogged with leaves, dirt, underbody protection and so on.
- Corrective action:
 - **Note:**
In the case of a sliding or tilting roof, the external rubber seal and the lock actuator or latch mechanism must be checked first of all.

Check the water trap for leaks.
 - Check the drain hoses for leaks and for correct connection to the water trap.
 - Check the drainage system for unhindered flow, and blow out with compressed air if necessary.
 - Check the external seal and the correct adjustment of the sliding roof.

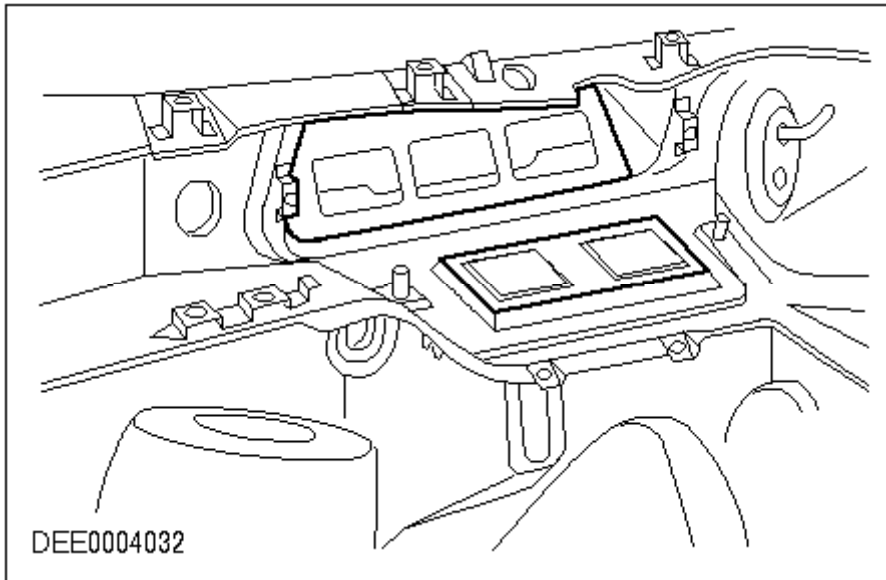
Heater and ventilation housing seal

- Diagnosis:
 - Ingress of water into the front footwell area
- Cause:
 - The apron panel is sealed in several places to adjacent components, such as at the joints to the A-pillar or to the floor pan. These seals can be broken.
 - The heater and ventilation housing is attached to the apron panel. The through area is sealed with a foam watershield that is fixed to the housing.
 - The housing has drain holes to allow the water to drain off.
 - If the foam watershield is defective or the drain hole is clogged, water can ingress into the front footwell area.

- Seal the broken seal welds.
- If a leak is found in the heater or ventilation housing, the drain holes must be checked first.

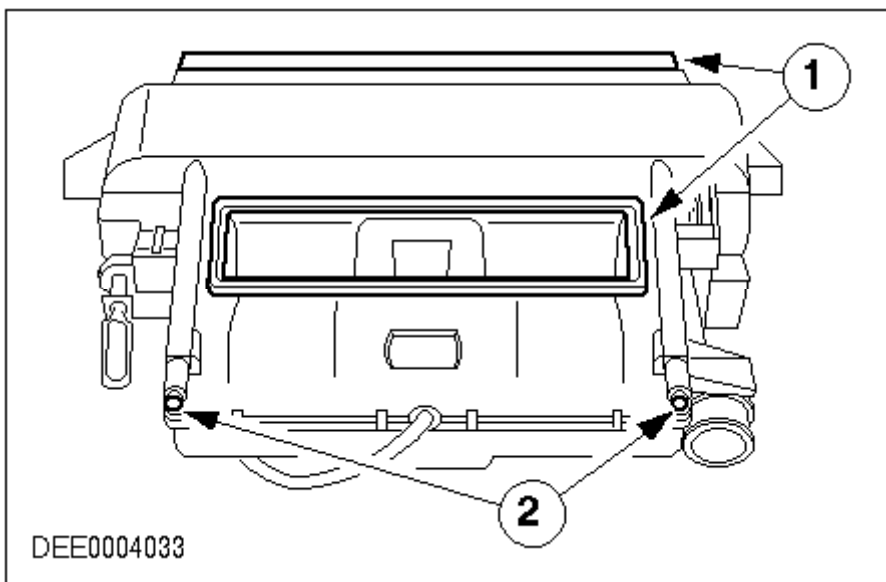
Checking foam watershields and water drain holes

The housing may have to be removed to check the foam watershield and its bearing surface for damage.

Damaged foam watershield must always be renewed.

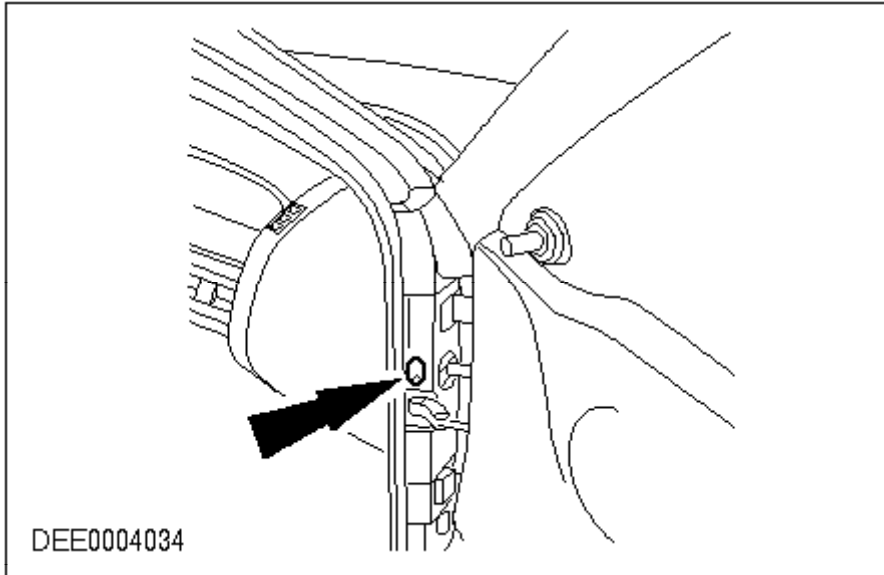
Door light switch seal

- Fastening bolts and routing holes for cables and hoses must be checked for leaks in the area of the apron panel and instrument cluster (rubber grommets in particular).
- If the footwell area is wet, then the door hinge seal, the door light switch and cable routing holes must also be checked.

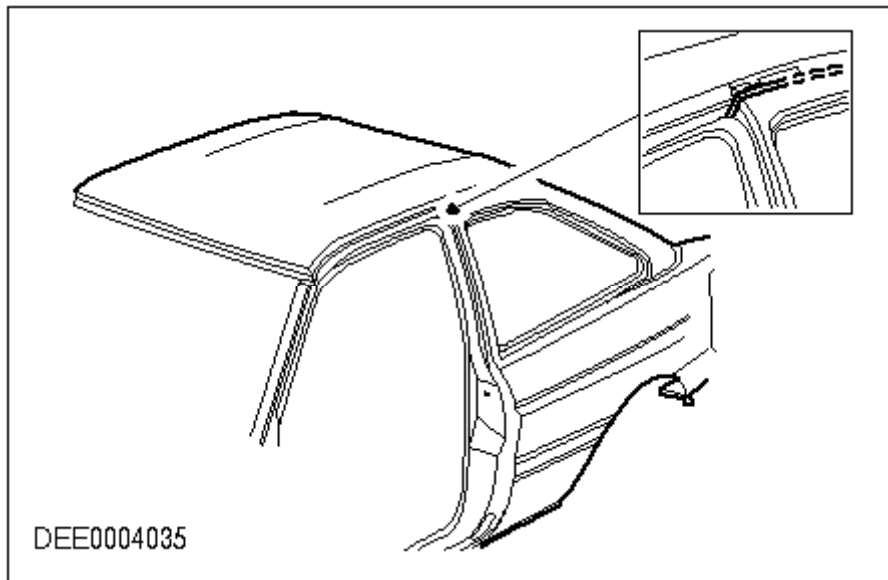
Drip rail seal

- Diagnosis:
 - Ingress of water into side headlining area
- Cause:
 - The roof outer panel is sealed with a seal weld at the connection point to the side panel. This seal weld can be concealed with a bezel or trim strip.
 - In the case of estate and hatchback vehicles, there is an additional seal to the rear roof crossmember.
 - Water can enter here if there is a break in the seal weld.
- Corrective action:
 - Remove trim strip or bezel. Check and re-seal the seal weld.

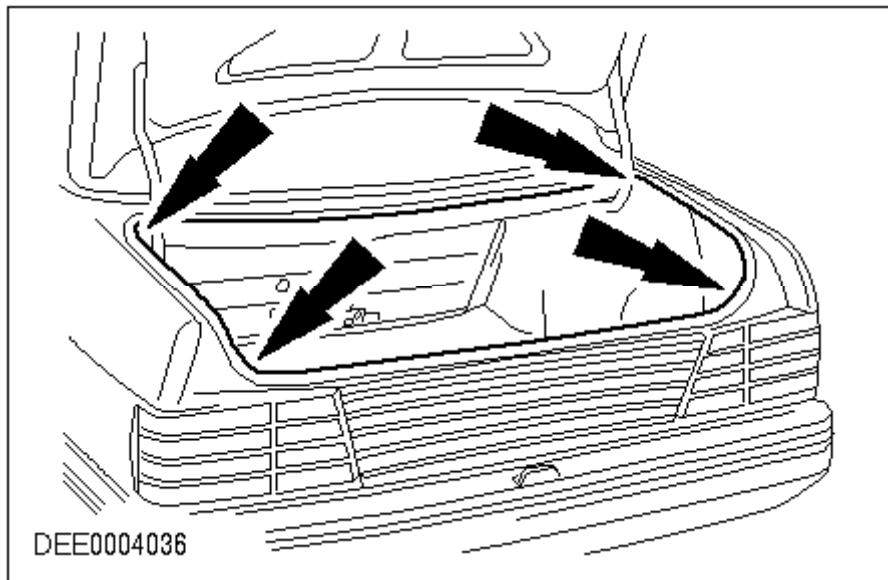
Check the seal for correct installation position

- Diagnosis:
 - Ingress of water into the luggage compartment
- Cause:
 - The luggage compartment lid seal corresponds to the door seal.
 - If there is a water leak, the seal must be checked for damage and the seal carrier must be checked for correct seating.
 - The clamping load and the bearing surface of the lid must also be checked for leaks.
- Corrective action:
 - The adjustment of the lid is made using the lock striker or the lock.
 - Rubber bump stops are attached to both sides of the luggage compartment opening. These are normally adjustable, and the clamping load can be modified.
 - The narrow radii of the luggage compartment lid seal are also problem areas.

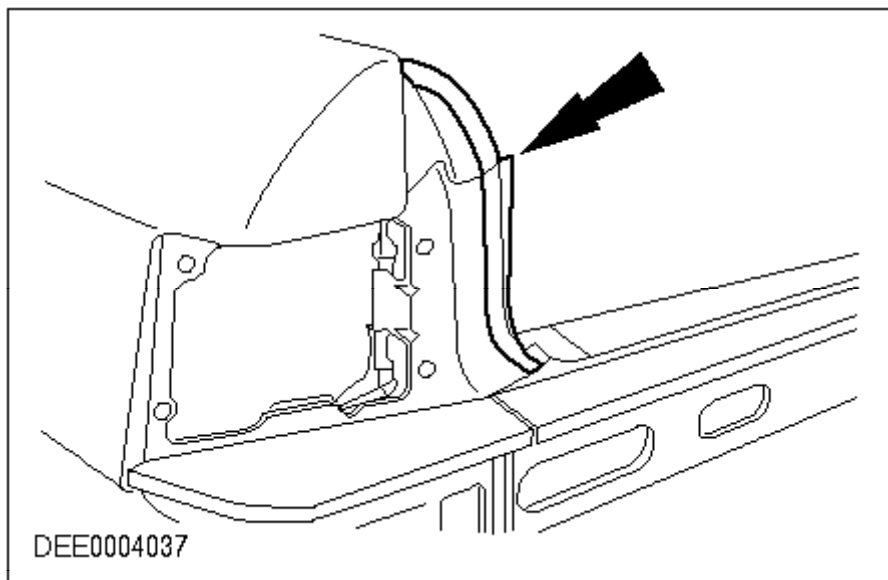
Uneven welded flange.

- Other cause:
 - The seal is not attached evenly around the lid because of a deformed or uneven welded flange.
- Corrective action:
 - Check the seal and bearing surface.
 - Re-align a deformed or uneven welded flange.

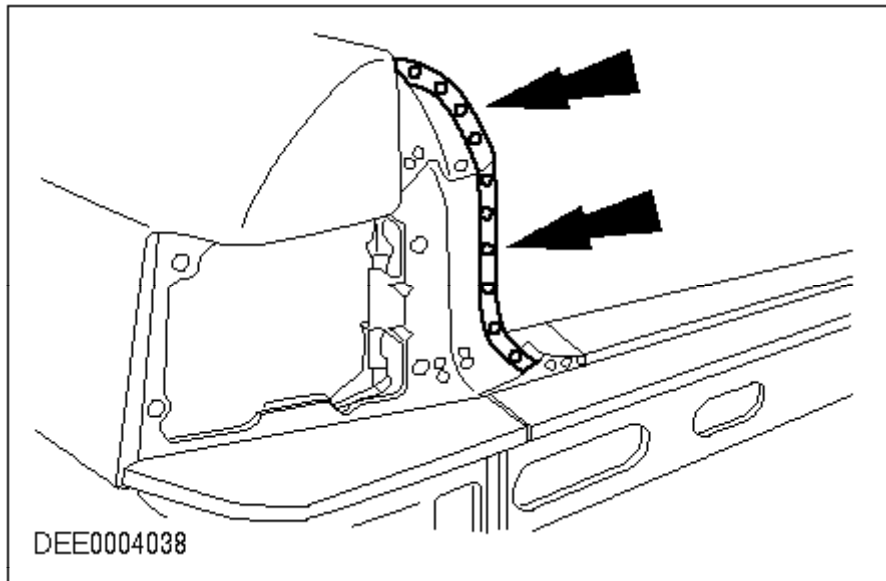
Welds melted through

- Other cause:
 - **Note:**
The seal carrier covers a defective weld.
 - Leaking weld on welded flange (melted through). Water can ingress into the luggage compartment under the seal carrier.
- Corrective action:
 - Pull the seal from the seal carrier.

- Seal the leaking weld using sealing compound.

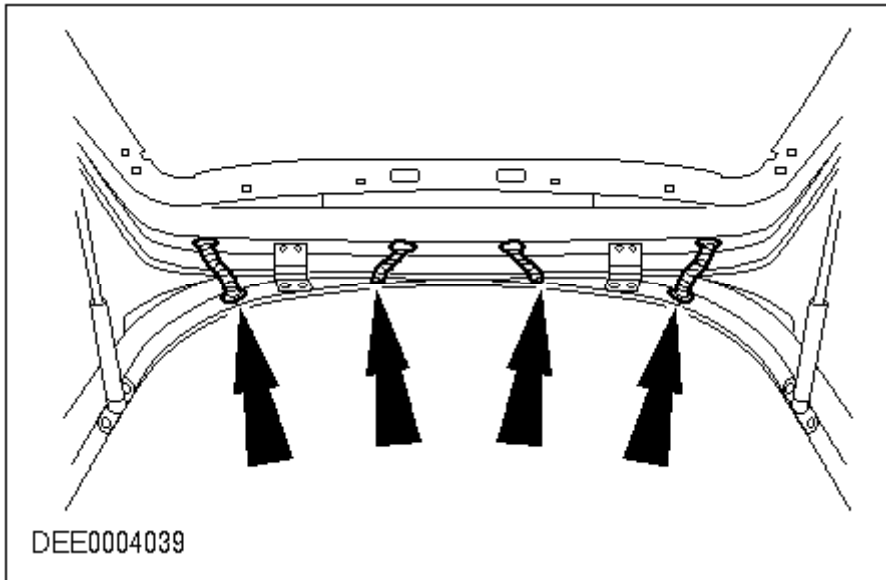
Check the routing holes for rubber grommets, cables and hoses

- Diagnosis:
 - Ingress of water into rear headlining area
- Cause:
 - The leak problems of the tailgate correspond to those of the doors.
 - In addition to this, the area to be sealed is much bigger. The routing holes for cables and hoses must also be sealed.
 - The rubber grommets for the routing holes must be checked for damage and correct seating (fully unhooked).
 - The mounting points of the tailgate hinges may leak.
- Corrective action:
 - Check the rubber grommets and renew if necessary.
 - Check the hinge mounting points, and re-seal with sealing compound if necessary.

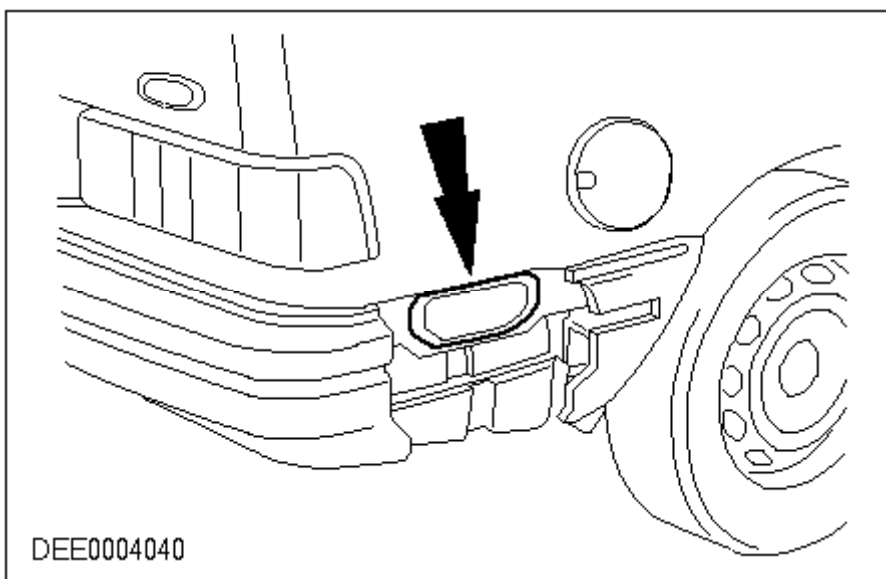
Check the seal for the forced air extraction.

- Diagnosis:
 - Ingress of water into side luggage compartment area
- Cause:
 - The forced air extraction for the vehicle interior is often located in the lower side panel area of the luggage compartment. The ventilation housing is sealed with a foam watershield on the bodywork side.
 - The rubber flap of the forced air extraction must be able to move freely.
- Corrective action:
 - Remove the forced air extraction. Detach the bumper if required.
 - Check the seal area between the bodywork and housing, as well as the rubber flap.
 - Renew a damaged foam watershield if necessary.

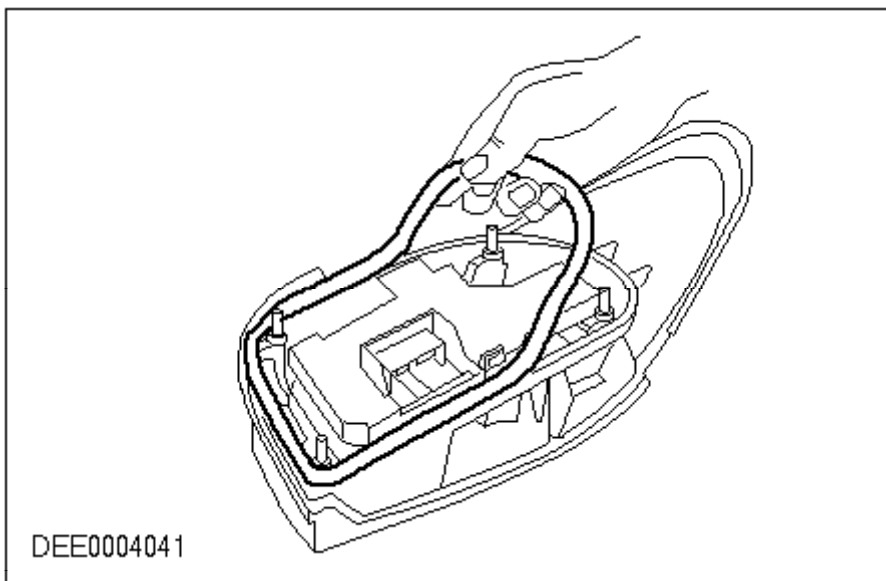
Check the seal for the rear lights

- Diagnosis:
 - Ingress of water into rear luggage compartment area
- Cause:
 - Rear lights are leaking. There are two sealing methods:
 - Sealing with a foam watershield
 - Sealing with plastic sealing compound
 - If a rear light has a leak, this usually means that the seal was fitted incorrectly.
- Corrective action:
 - Remove the rear light. Check the housing and glass for damage. Check the plastic seal for leaks.

The sealing compound must always be removed during repair work.

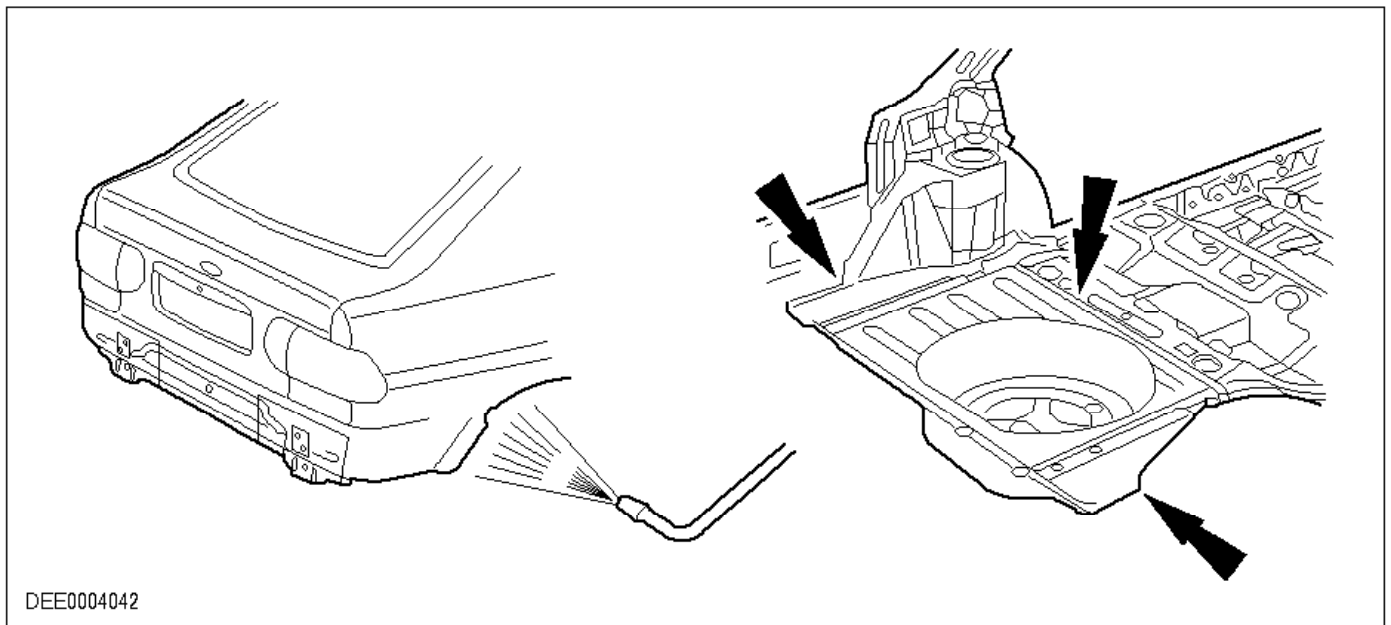
Possible water leaks at the panel connections in the luggage compartment

- Diagnosis:
 - Ingress of water into the luggage compartment area

- Cause:
 - Several panel connections must be fitted in production in the wheelhouse and luggage compartment areas. These connections are sealed with sealing compound.
 - Uneven application of sealing compound can lead to a break in a seal weld.
- Corrective action:
 - Expose the seal weld.
 - Locate the leak in the seal weld.
 - Re-seal using sealing compound.
